Concrete Protection System

4000 Series BELZONA 4151

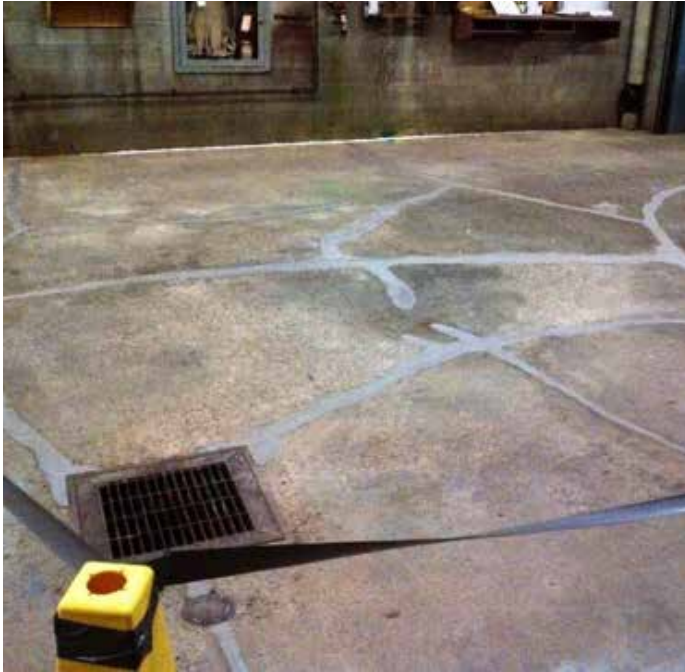
Crack repaired with Belzona 4151 and 4111 system

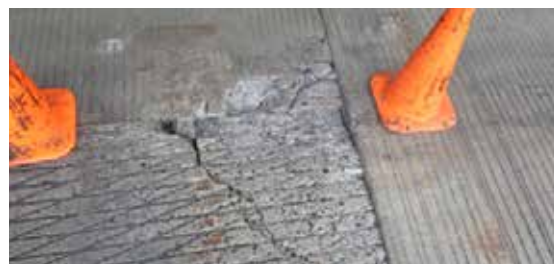
A concrete panel had cracked causing problems on the road

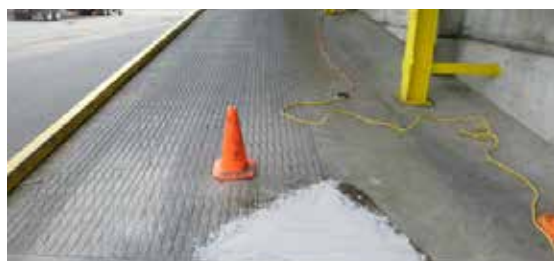
The Belzona 4151 + 4111 system was used to rebuild and smooth the cracked area

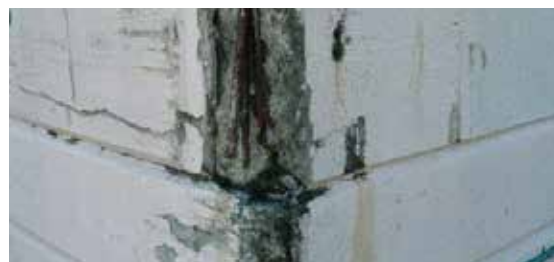
A wall corner was severely damaged

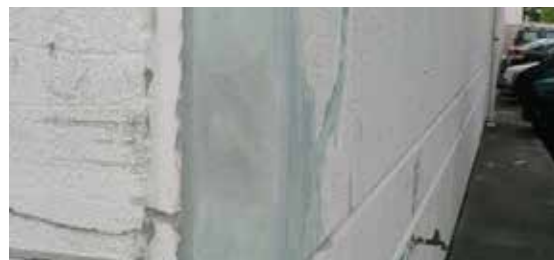
Belzona 4151 was injected before cracks were filled with Belzona 4111
